MEMORANDUM

AGENDA ITEM #IV.G

DATE: JULY 22, 2019
TO: COUNCIL MEMBERS
FROM: STAFF
SUBJECT: APPROVAL OF EXPENDITURE – AIR CONDITIONING SYSTEM

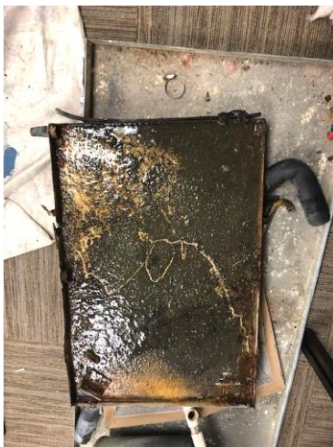
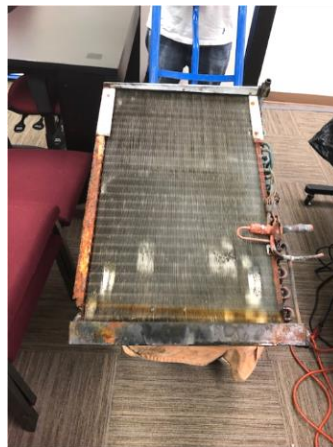
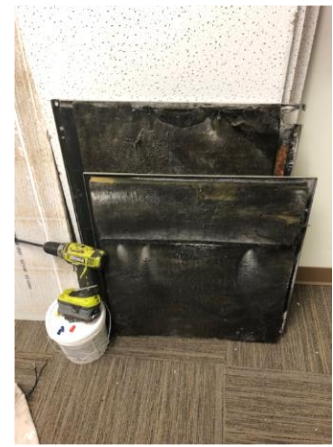
After checking out the system's supply and return temperatures, we identified several problems with this unit as shown in the pictures sent:

- The unit is running on a 410A condensing unit with an R22 air handler without replacing the TXV
- The air temperature difference between the supply and return is above 20 degrees Fahrenheit which indicates air flow restriction

- Return grill has dampers that need to be replaced because they are causing air flow restrictions
- The $\frac{3}{4}$ copper drain line is not allowing water to leave the system fast enough, increasing humidity

- Solution: replace drain line, it is possible $\frac{3}{4}$ drain line partially restricted due to age
- Evaporator coil is dirty
- Drain pan rusted
- Blower motor wheel is dirty and rusted, not circulating enough air flow

- Overall condition: the system is recommended to be replaced and properly matched with the assisting unit
- NOTE: system does not have a smoke alarm required by code, as a system over 1800 CFM is required to have a smoke alarm. If repair is performed, smoke alarm system must be installed.
